**C9xx: C911, C931, C941, C942** (See OkiDoc 4259)

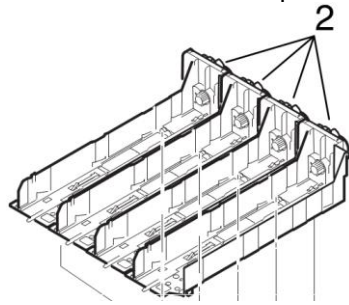
2. Toner leakage on the Image drums

- When the toner leakage is reported, please ask to send the picture and check SN.
- If the manufactured month was more than 1 year ago, we should suspect the ducts:

**Duct Assembly** (2 Frame Assy.-TC) Regarding the toner leakage onto the drums and the ducts possibly needing to be replaced.

I have included a PDF with the part that would need to be replaced highlighted. The part is not spared out so there is no part number for it. Please speak with Brian, Al , or Gary as there is a special kit that has been put together to service this issue.

Old Duct Frame Assy MUST be returned to us. (Tag in box to Gary) Small % drop (Not →10)

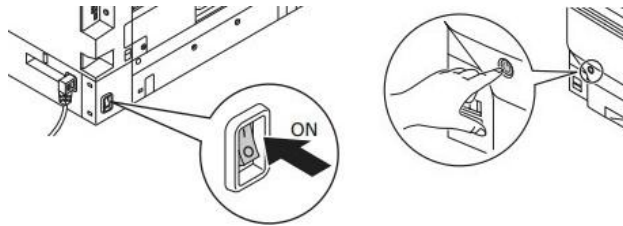
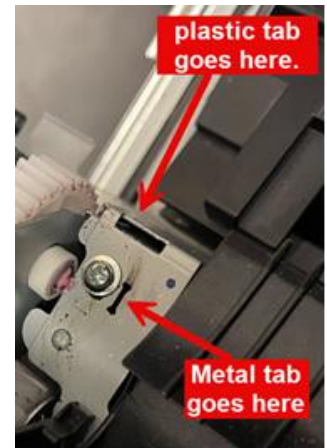
**Power On** - I said to turn on the left rear switch (under the ports) first, then press the power switch on the front left (over tray 1).

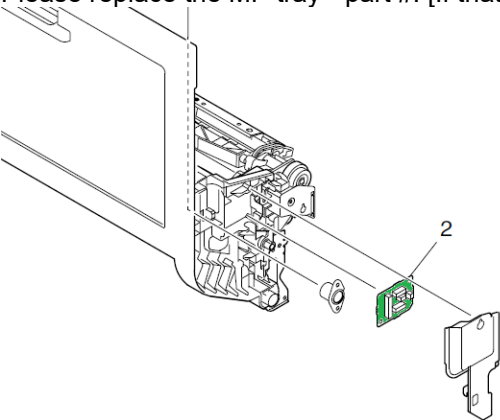
**125 Error** - Error detected at **MT** home position. **Cause:** Multi-purpose Tray Home Error - Does the motor run in the motor testing of the PU self-diagnostic mode. **Yes** - Check the sensor cable for a break or short, and the connector semi-locking relay PCB and the printer control PCB for abnormal condition. / **No** - Check the hopping motor and the gear train for abnormal condition.  
-Paper tray maybe stuck up. By Feeder?  
I walked him thru doing a motor Clutch test on the MPT lift-up motor and the MPT motor and they both passed. I then had him do a Switch Scan test on the MPT PE\_PNE\_LIFT sensor and they toggle from H to L as well.  
There is a relay board on the side of the MPT #2 45540301 OR-Board-F1S. It may be that the cables were too tight and pulled out. I would check this and the cable that runs to the board. Do a continuity check through the cable.  
(Check the MPTIF 12 pin connector from the CUPU to the MPT Relay board.)

Please replace the MP tray - part #. [If that fails, PU] [If that fails - Registration Motor 45192901]
