**C9xx: C911, C931, C941, C942** (See OkiDoc 4259)

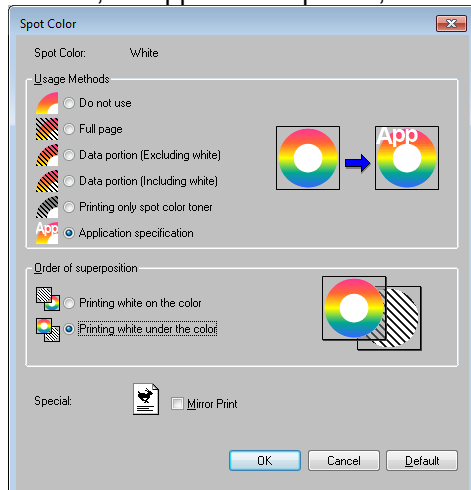
C941 - Printing white under color. In Printing Preferences click on the Color Tab and click the Spot Color Button. Select the usage method, ex Application Specific; then set Order of Superposition to Printing white under the color.
